## Update on the Track Fitter(TF)

6<sup>th</sup> SVT workshop Sep. 10-11, 02 Un-ki Yang, Univ. of Chicago

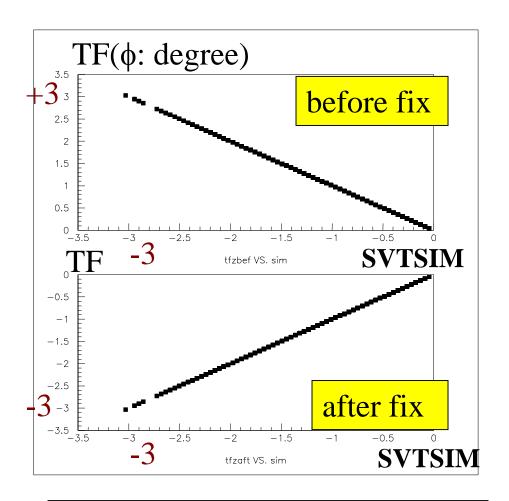
TF vs SVTSIM in φ

- $\rightarrow$   $\phi$ =0 problem was fixed.
- A possible source of the TF failure in Flash MEM (one per 1-2 months) was eliminated.
- $\phi$ =0 problem!  $\phi = \phi_0 + \delta \phi_0 (= \mathbf{f}^* \delta \mathbf{x}, 8 \text{bits})$ (13bits from 0 to  $2\pi$ ) Negative  $\phi$  value occurs, if  $-\delta \phi_0 > \phi_0$  (around +0).

- A test in B0 Teststand shows that this problem occurs at 7% rate in wedge 0.
- No problem appears with fixed version of firmware (correction was done within 8 LS bits=11°).

- 1. Install updated firmware on the other 11 Rev-B TFs and 2 Rev-A TFs.
- 2. Need to fix problems in two spare TFs (Rev-B): VME block data transfer in one TF, stability check on another TF (currently, working spare boards: 1 Rev-B, 2 Rev-A TFs)
